RFI59

Project: COOLEY LABORATORY RENOVATION
Job: 3146 COOLEY LAB, PPA# 10-0023
Customer: STOFMT MSU BOZEMAN

Item: HELICAL PIER AT ARC ENTRANCE

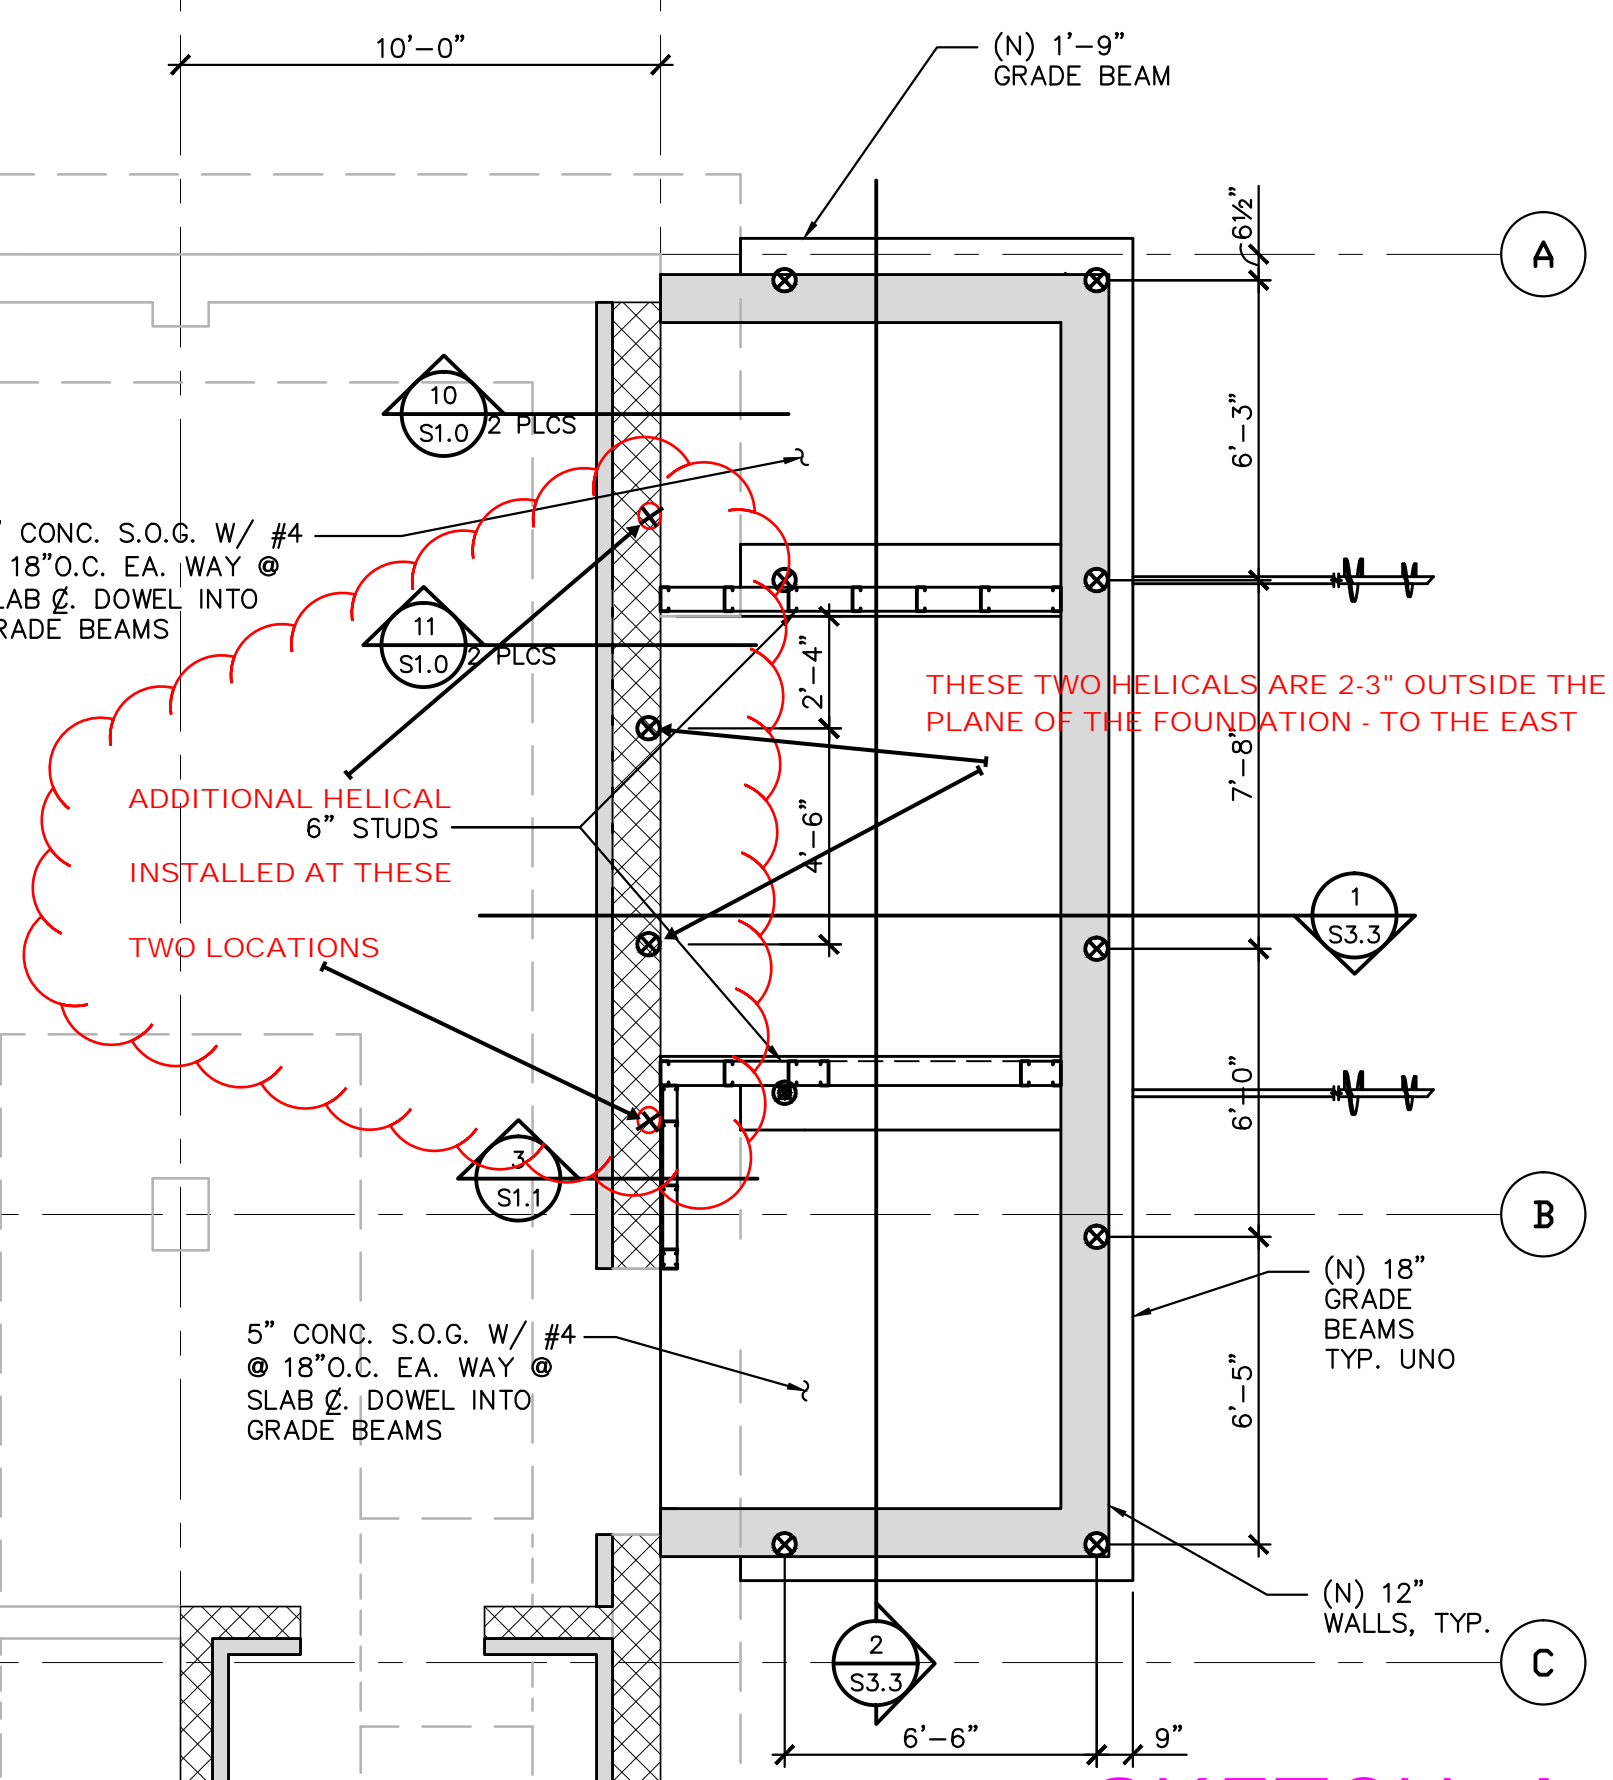
SKETCH A

The two helical piers shown within the elevator pit have been installed. Both of the underpinning brackets are skewed within the plane of the elevator pit. The counterbalance weights and cab rails would be in conflict. To resolve the situation we would propose to remove the vertical leg on the Chance Bracket and push the bracket to the west until it is out of conflict approximately 2 to 3 inches.

SEE FIELD CONSTRUCTION REPORT DATED NOV 29TH
(ITEM #8) FOR NOTES ON THE INSTALLED PIERS.
AEGIS ENGINEERING DOES NOT HAVE A PROBLEM WITH
THE PROPOSED REALIGNMENT OF THE HELICAL PIERS
PROVIDED THAT THE HELICAL PIER MANUFACTURER
APPROVES THE CHANGES.
