RFI59

Project: COOLEY LABORATORY RENOVATION
Job: 3146 COOLEY LAB, PPA# 10-0023
Customer: STOFMT MSU BOZEMAN

Item: HELICAL PIER AT ARC ENTRANCE

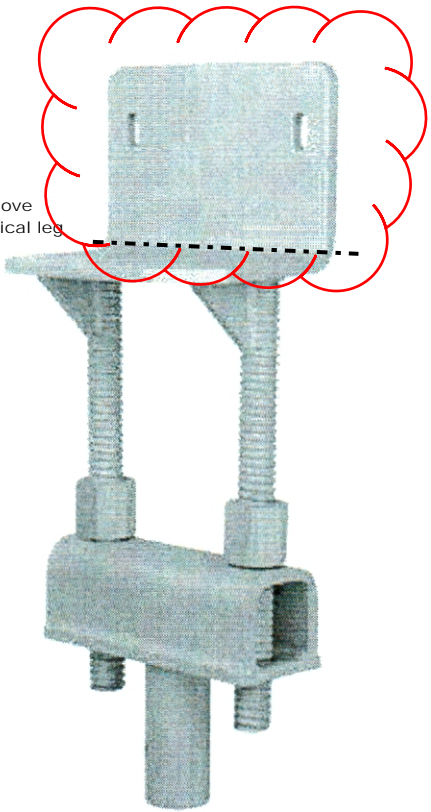
SKETCH B

The two helical piers shown within the elevator pit have been installed. Both of the underpinning brackets are skewed within the plane of the elevator pit. The counterbalance weights and cab rails would be in conflict. To resolve the situation we would propose to remove the vertical leg on the Chance Bracket and push the bracket to the west until it is out of conflict approximately 2 to 3 inches.

Remove
Vertical leg

Proposed solution is to cut top leg of helical attachment and jack the top of the helical under the Foundation system until it is within the place of the foundation.
